Len Wishart-Rehab Specialist
Albemarle Housing Improvement Program
lwishart@ahipva.org

Lee Miller Rehab Specialist
Albemarle Housing Improvement Program
lmiller@ahipva.org

Hazardous Materials

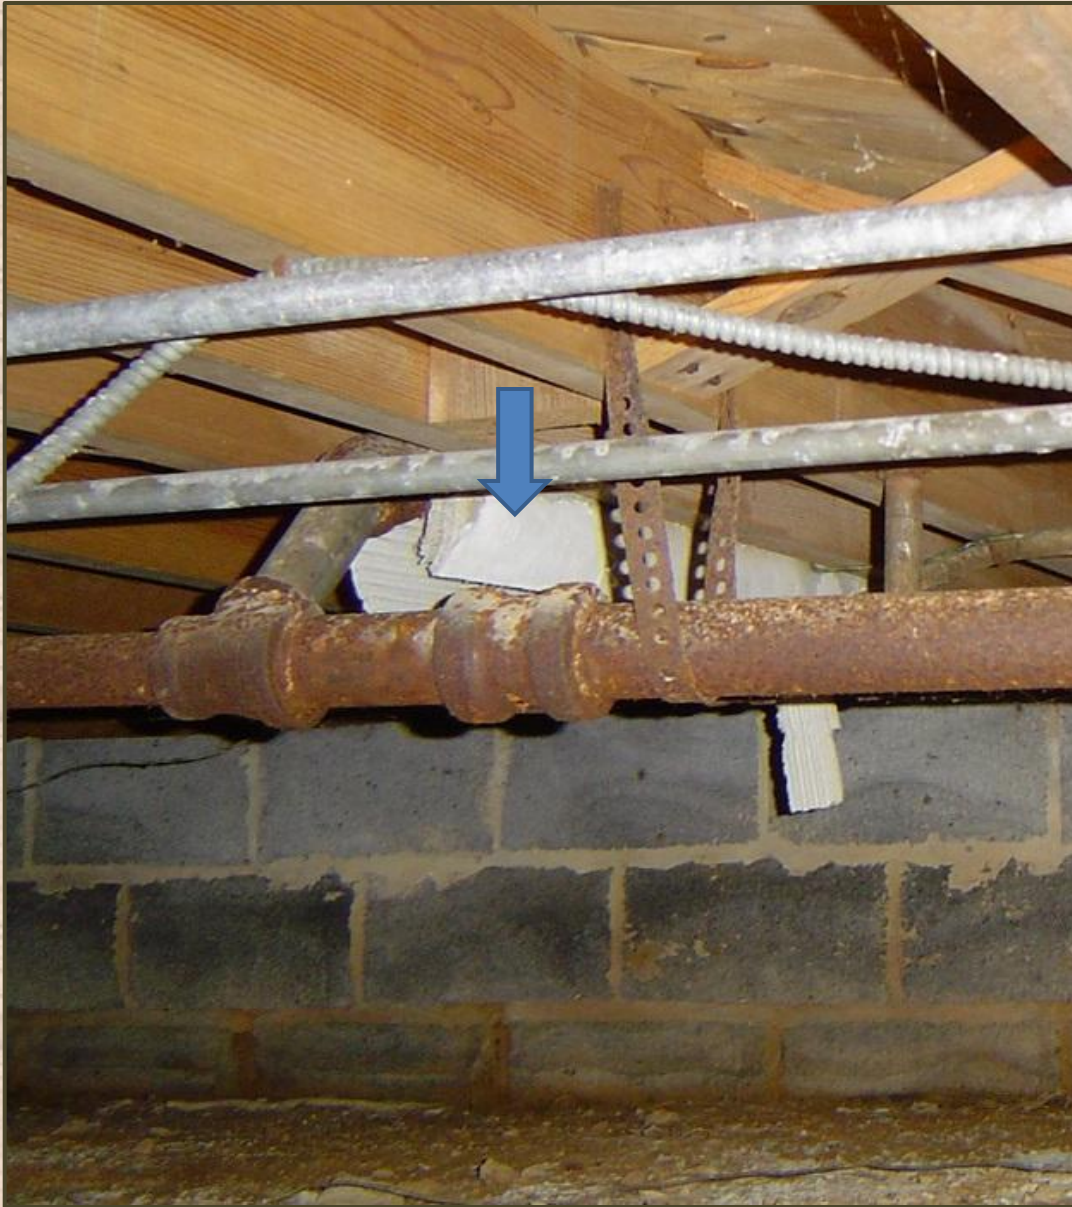
Asbestos pipe insulation

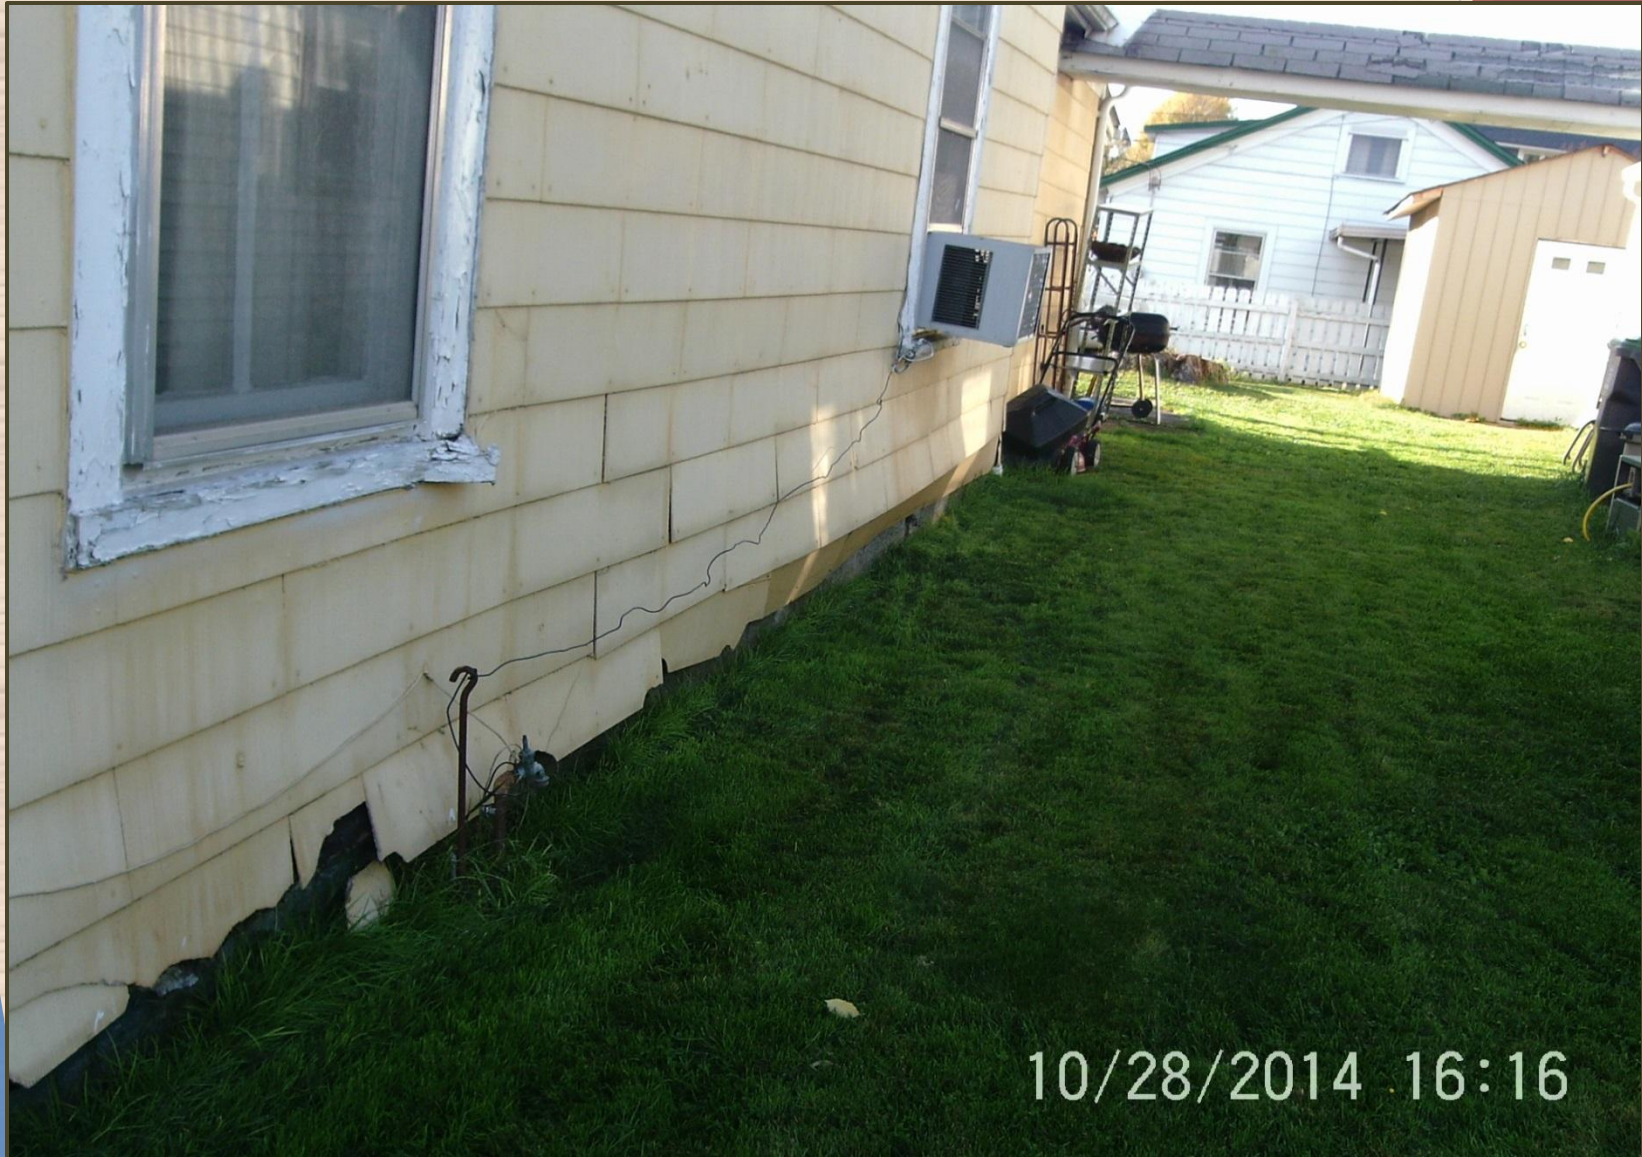
Asbestos Siding

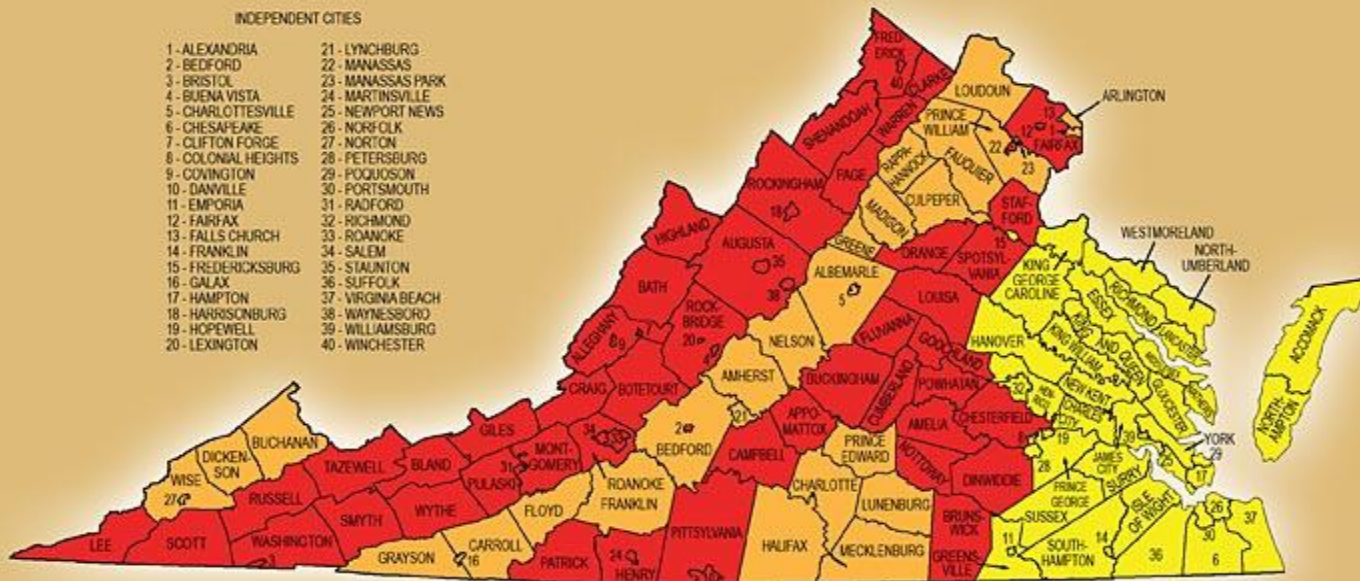
RADON MAP of VIRGINIA

- Zone 1 counties have a predicted average indoor radon screening level greater than 4 pCi/L (pico curies per liter) (red zones)
- Zone 2 counties have a predicted average indoor radon screening level between 2 and 4 pCi/L (orange zones)
- Zone 3 counties have a predicted average indoor radon screening level less than 2 pCi/L (yellow zones)

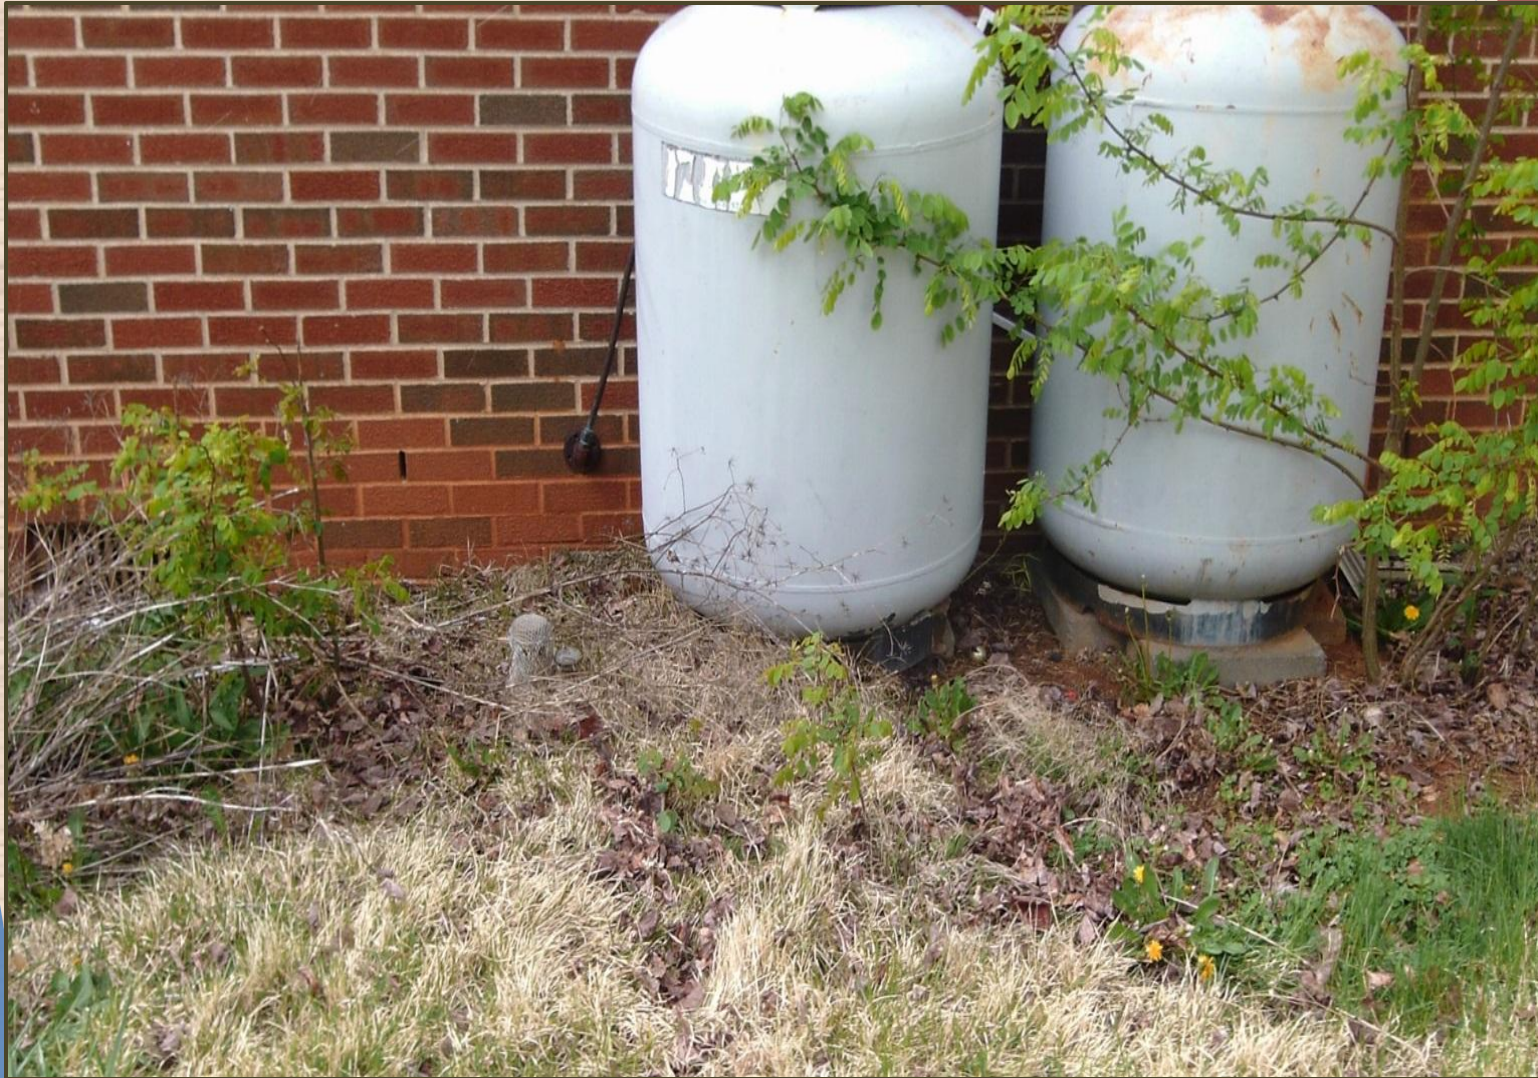
Alternate fuel source for furnace

This UST was abandoned. After inspection that fill tube was opened; uncap, probe with rod, sand can be felt inside the tank.

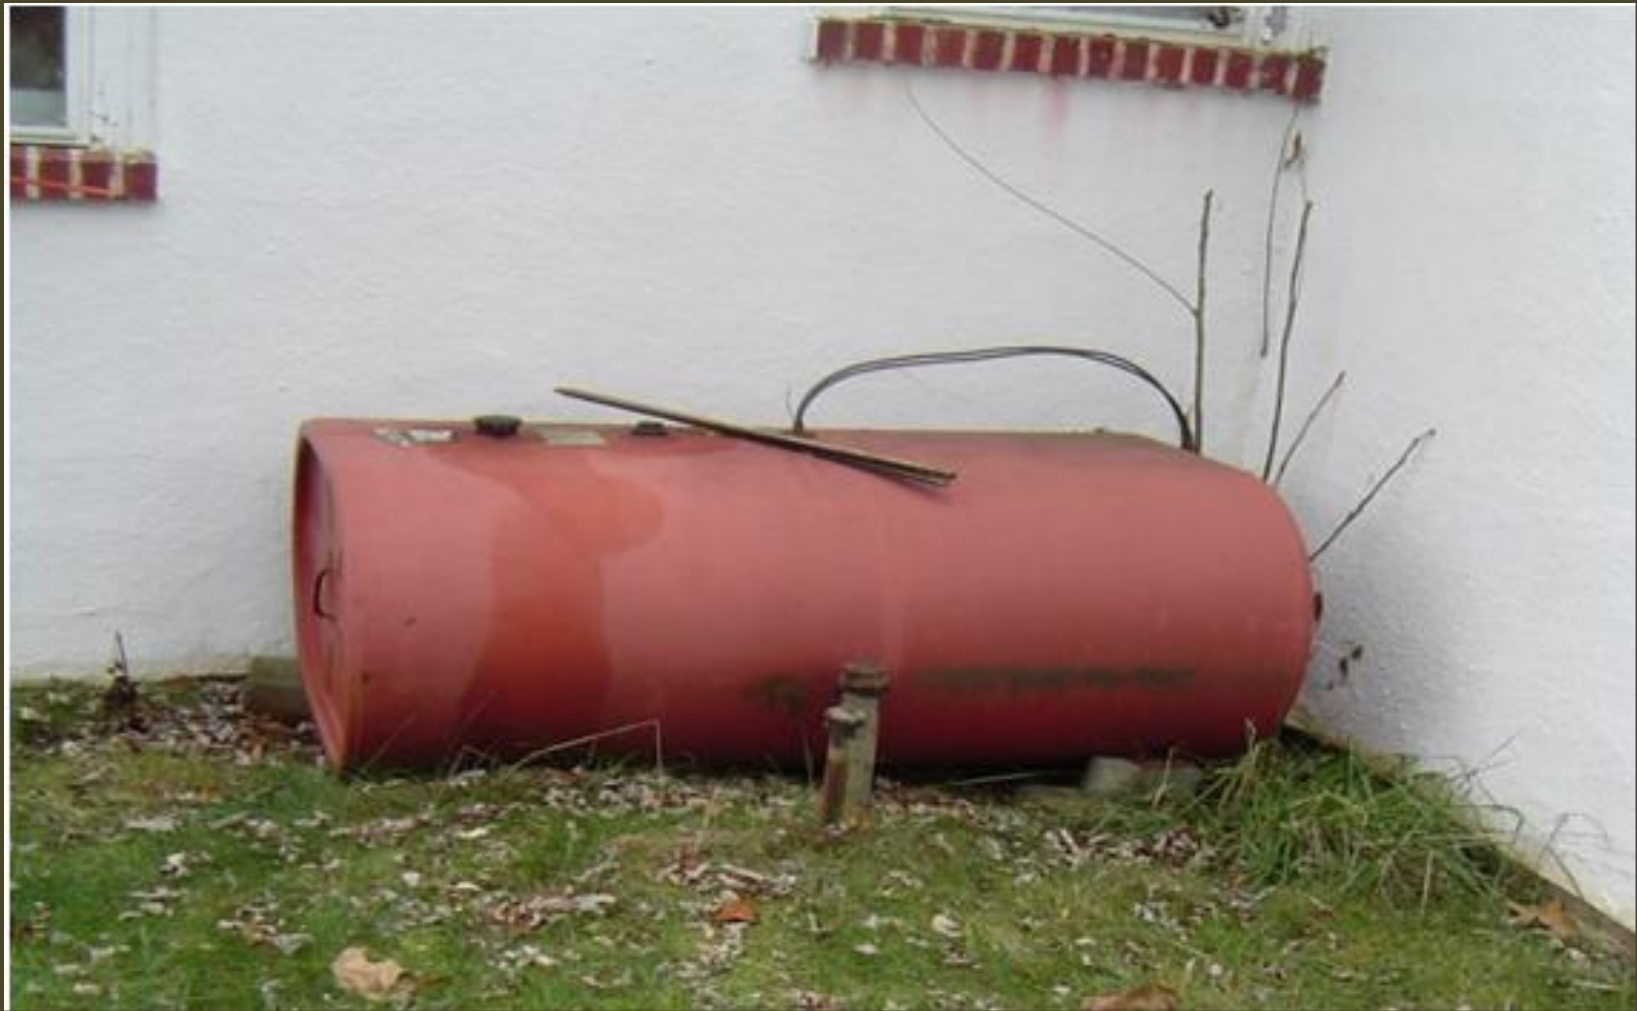
Above-ground Storage Tank on top of UST

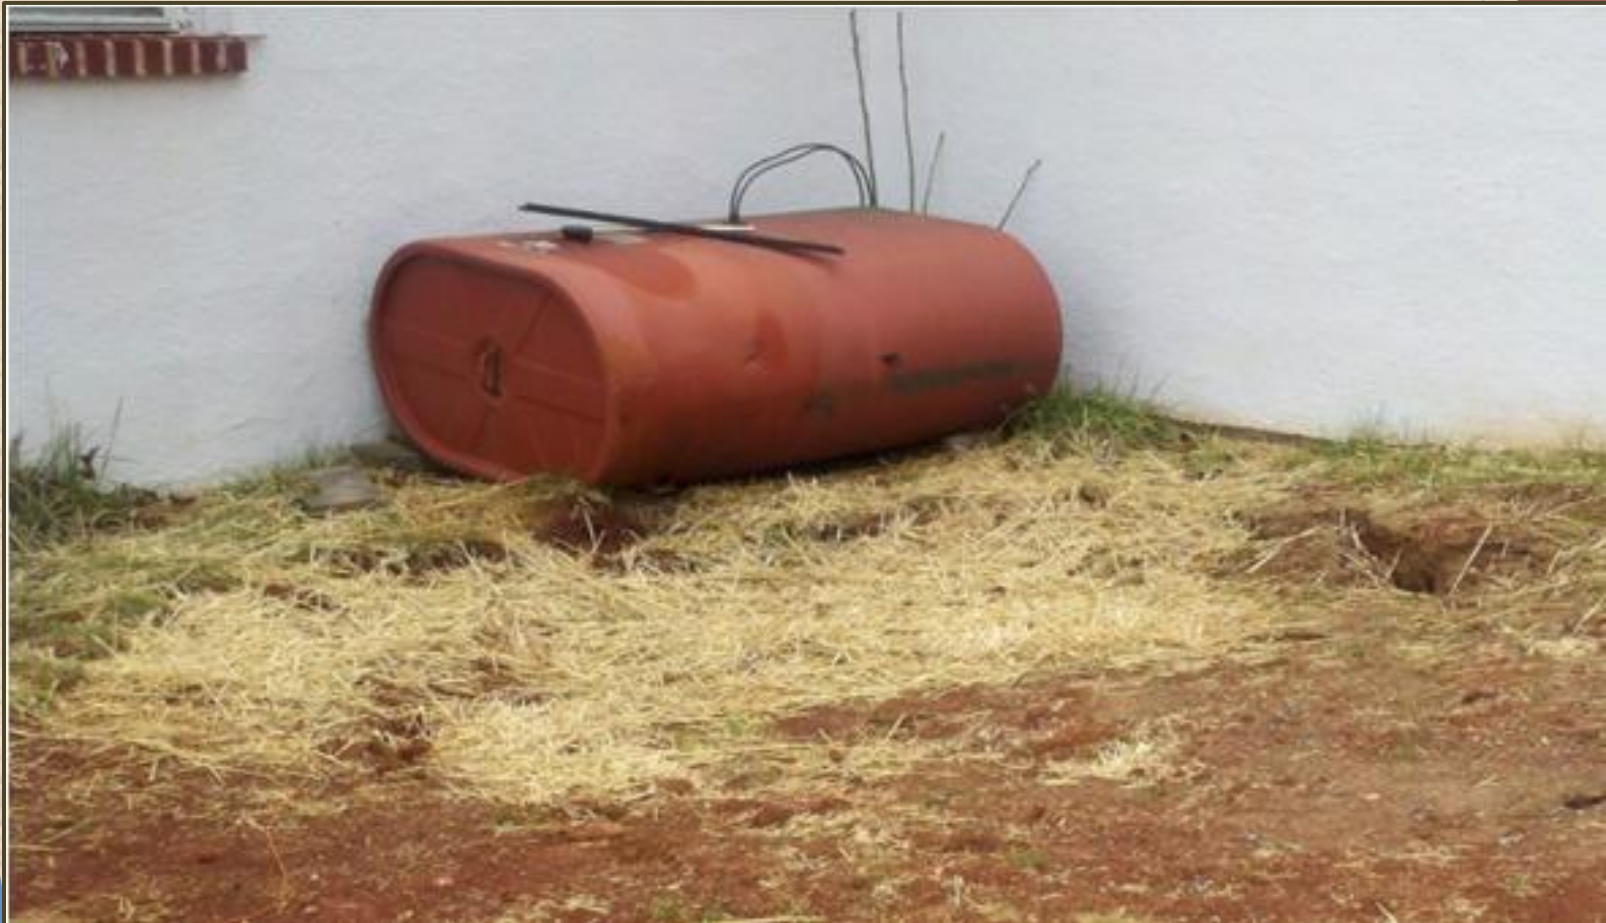
Old tank removed and existing tank reinstalled
